# Manhole Inspection Summary

Manhole # S17GG\_022MH

Insp Date: **6/12/07 10:58 AM**

**Location** Address: **1517 BENTALOU-SMALLWOOD** Cross Street: **PRESSTMAN ST**

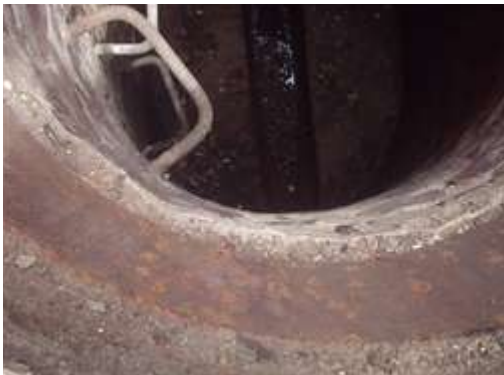
Defect 1

**Frame** Offset: **1** (in.) Condition: ☒ Sound ☐ Cracked ☐ Leaks

FRAME OFFSET

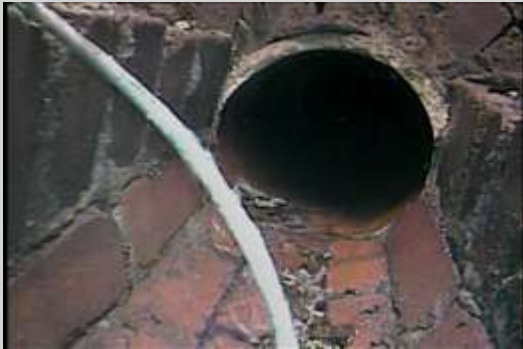
12 O'Clock Outflow

8 in. Circular Gravity Sewer  
Pipe Out @ 12 O'Clock

Pipe Height: **8.4** (in.) Rod and Bar (Angled)  
Pipe Material: **Clay** ☐ Pipe Lined  
Invert Depth: **7.64** (ft.) Flow Characteristics: **Slow**  
Deposits: ☒ None ☐ Mud ☐ Sludge ☐ Debris ☐ Grease  
Silt Depth: (in.) Deposits Extent:  
Infiltration: **None** Pipe Seal Cond: **Broken**

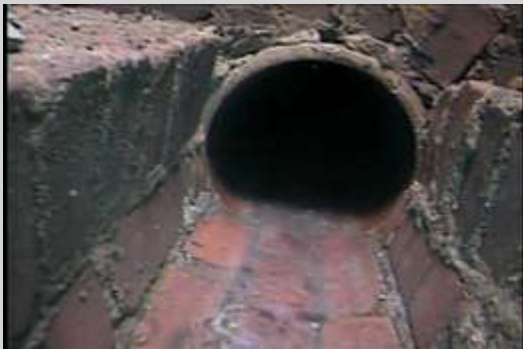
6 O'Clock Inflow

8 in. Circular Gravity Sewer  
Pipe In @ 6 O'Clock

Pipe Height: **8.4** (in.) Rod and Bar (Angled)  
Pipe Material: **Clay** ☐ Pipe Lined  
Invert Depth: **7.60** (ft.) Flow Characteristics: **Slow**  
Deposits: ☒ None ☐ Mud ☐ Sludge ☐ Debris ☐ Grease  
Silt Depth: (in.) Deposits Extent:  
Infiltration: **None** Pipe Seal Cond: **Sound**
